DEPARTMENT OF TRANSPORTATION

Contract #: 04-0120F4Cty: SF/ALA Rte: 80 PM: 13.2/13.9File #: 69.28**WELDING INSPECTION REPORT****Resident Engineer:** Pursell, Gary**Address:** 333 Burma Road**City:** Oakland, CA 94607**Report No:** WIR-004078**Date Inspected:** 28-Sep-2008**Project Name:** SAS Superstructure**OSM Arrival Time:** 1400**Prime Contractor:** American Bridge/Fluor Enterprises, a JV**OSM Departure Time:** 2300**Contractor:** Zhenhua Port Machinery Company, Ltd (ZPMC), Changxing Island **Location:** Shanghai China**CWI Name:** Sun Wei**CWI Present:** Yes No**Inspected CWI report:** Yes No N/A**Rod Oven in Use:** Yes No N/A**Electrode to specification:** Yes No N/A**Weld Procedures Followed:** Yes No N/A**Qualified Welders:** Yes No N/A**Verified Joint Fit-up:** Yes No N/A**Approved Drawings:** Yes No N/A**Approved WPS:** Yes No N/A**Delayed / Cancelled:** Yes No N/A**Bridge No:** 34-0006**Component:** OBG**Summary of Items Observed:****OBG Bay 1**

WELDING INSPECTION REPORT

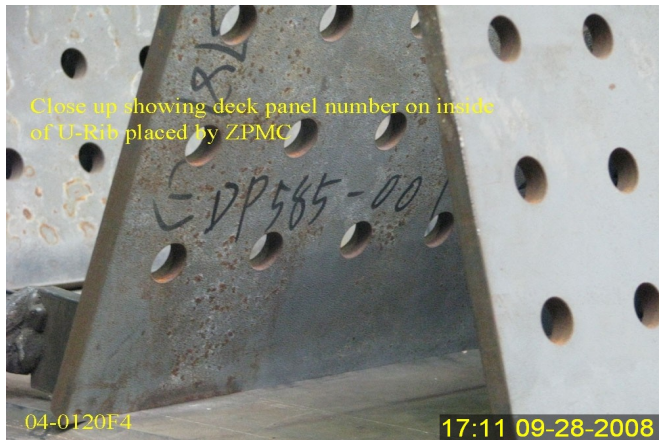
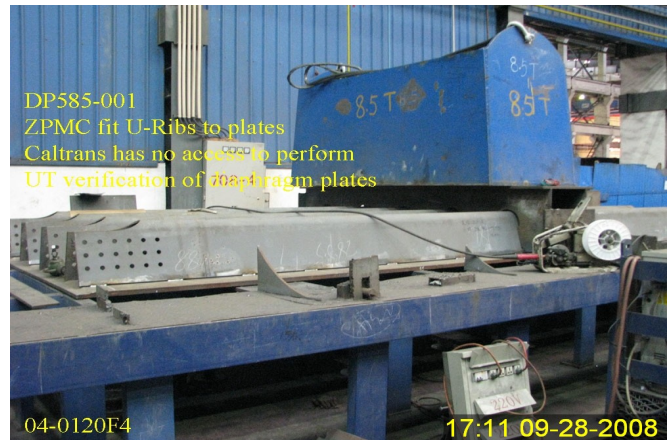
The Caltrans QA observed ZPMC has approximately thirty (30) to forty (40) workers performing various functions relative to the fabrication of the OBG Deck Panels. These functions include; closed rib milling, PJP weld joint beveling, drilling thru holes, press forming, closed rib splice welding, closed rib diaphragm fit-up and FCAW welding of splices, closed rib to deck plate fit-up and tack welding and the PJP welding of closed ribs to deck plates. Deck Plates at the gantry stations were, Gantry-1 DP497-001 had SAW and GMAW completed previously. Gantry 2-DP411-001 had SAW and GMAW completed previously. Tack welding table had 3 deck panels in process for fit and tack welding which were DP540-001, DP545-001 and DP585-001. Caltrans QA inspectors received a notice of inspection from ZPMC for the diaphragm plates on DP585-001 which when this QA inspector arrived to perform the QA review for UT the closed ribs were already fit to the deck plate the QA inspector was not able to perform the QA review due to no access.

This Caltrans QA observed ZPMC continuing with the fabrication of various Side, Bottom and Edge Panels designated for the SAS OBG. The general fabrication of said items consist of removal of coatings from weld joint areas, cutting, splitting of "W" shape beams for "T" stiffeners, splicing of plates, fitting, tack welding and welding. Various T stiffeners were in the beginning stage of being spliced a total of 14 were observed from fit-up to welding in process. This QA inspector received request for NDT witness in bay 3 on WT stiffeners CJP weld splice. This QA inspector performed the QA review after ZPMC had performed their UT testing of the areas and accepted these areas. The areas tested by ZPMC were 25% of the weldment as outlined in the contract documents. The items reviewed were SP576-001-037~048, SP616-001-037~048, SP536-001-043~056 and SP484-001-190~194. At the time of this QA inspectors review the weldments appeared to be within the contract

documents for the 10% performed.
